RESIDENTIAL INSPECTION - SAMPLE

1234 Main Street
Jacksonville, FL 32224

Buyer Name
02/01/2023 9:00AM

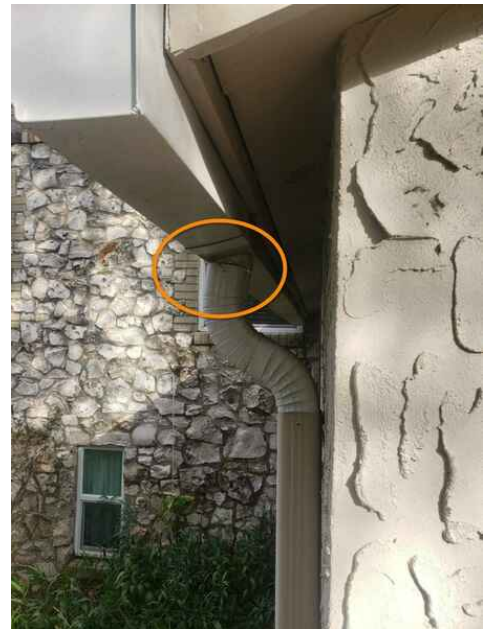
One or more downspouts designed to discharge roof drainage was disconnected. This condition can result in excessively high moisture levels in soil at the foundation that can cause damage related to soil/foundation movement. Any such downspouts should be re-connected in order to help protect the home structure.

Recommended DIY Project

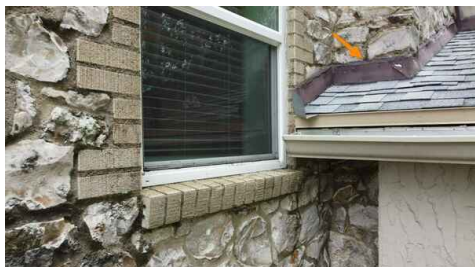
Flashing: Rubber Caulking 1

On the roof, counter flashing was not installed and sealant was substituted for this application. Sealant will eventually dry, shrink, and crack, leaving an opening for water intrusion. The sealant should be inspected on a regular basis and replaced before it allows roof leakage. Typically, a counter flashing is installed that is applied over the flashing touching the shingles and behind the wall covering (in this case the crystal stone). There is no counter flashing so the rubberized caulking has been applied to keep the water from penetrating behind the flashing. This rubberized caulking should be inspected periodically and reapplied when necessary.

Contact a qualified professional.

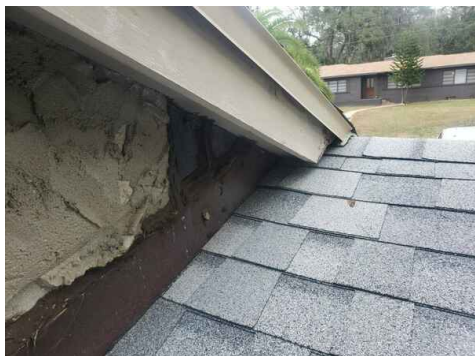
Flashing: Rubber Caulk also protecting building envelop where stucco is missing.

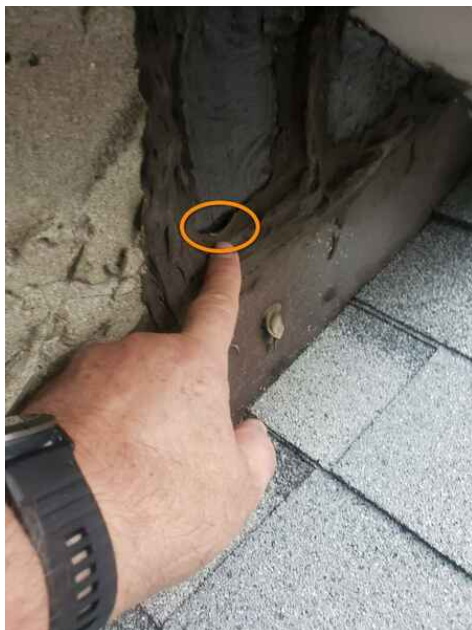
Flashing: Rubber Caulking Pulling Away

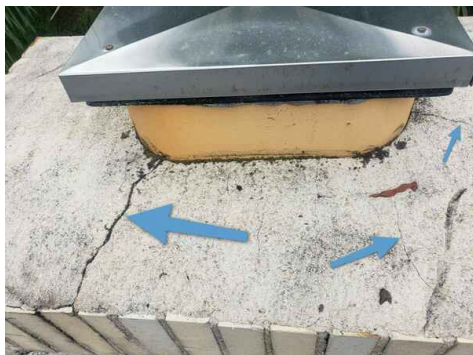
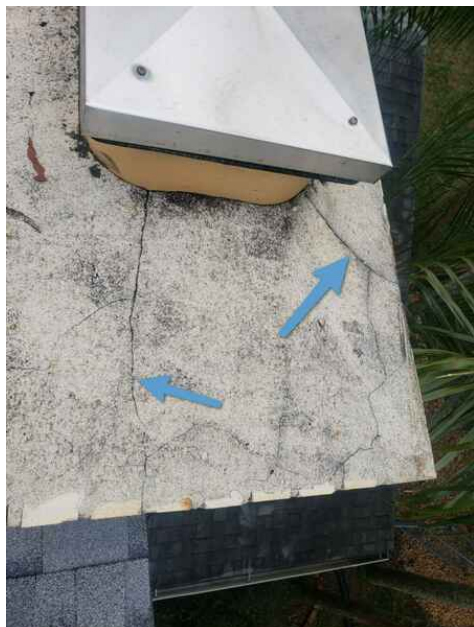
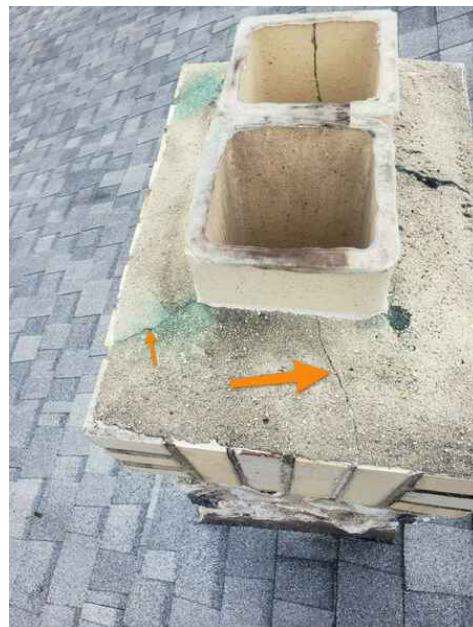
Chimney crown cracks may lead to water penetration down the chimney. Small cracks due to expansion and contraction are normal but should be monitored over time to prevent water penetration. There is one crack that appears to have been sealed before however, most of the sealant is gone. The other cracks should be monitored.

Contact a qualified professional.

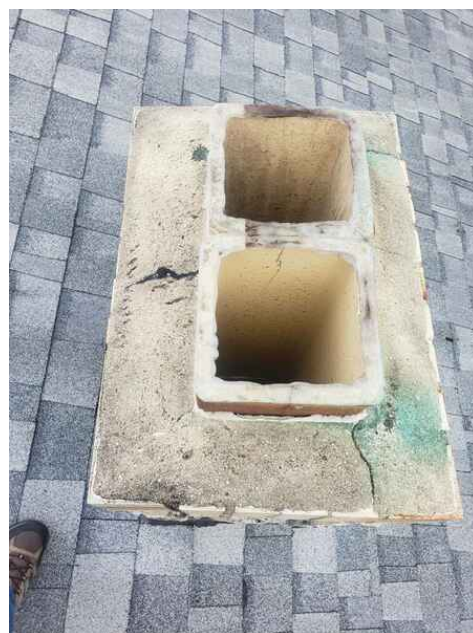
This chimney is no longer used. I recommend capping the top to keep water, animals, and insects from entering.

Recommend capping out of use chimney

Contact a qualified professional.

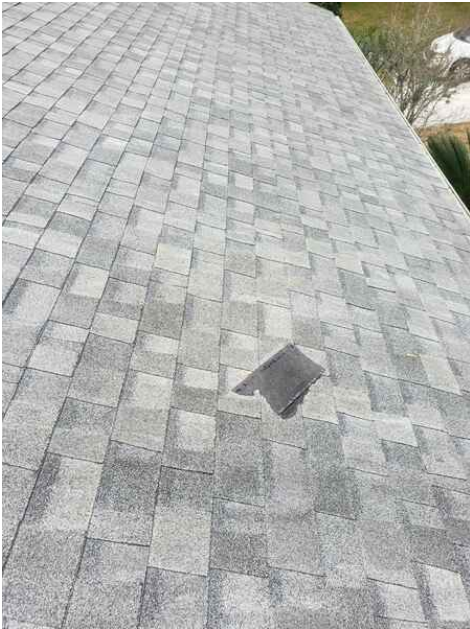
Debris on roofing material tends to hold moisture underneath. This moisture also shortens the useful life of the roofing material below it.

Front: Shingle from another roof

Contact a qualified professional.

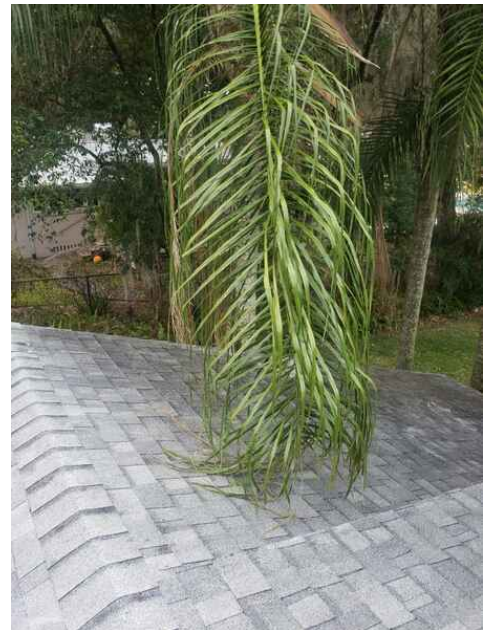
Tree limbs that overhang or touch a roof may cause damage in multiple ways. Shade does not allow the roof to dry properly following rains storms and may hold moisture which drips and creates additional wetness on roofing systems. Limbs that actually touch the roof can cause direct damage to roof surfaces in wind and rain conditions.

Tree touching roof

Contact a qualified professional.

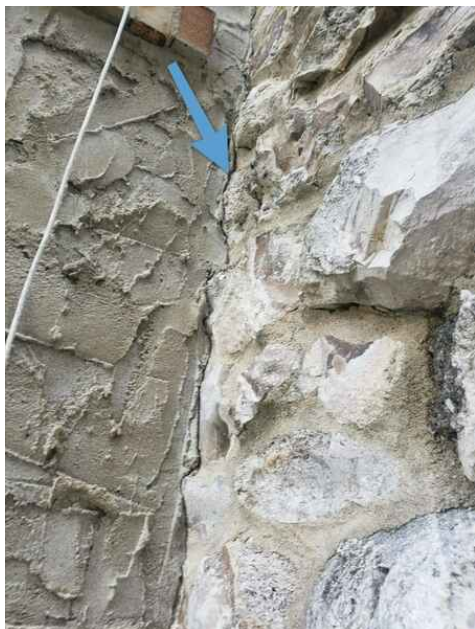
Crack where stone meets stucco. Water could pernitrate the gap and cause damage in driving rain conditions.

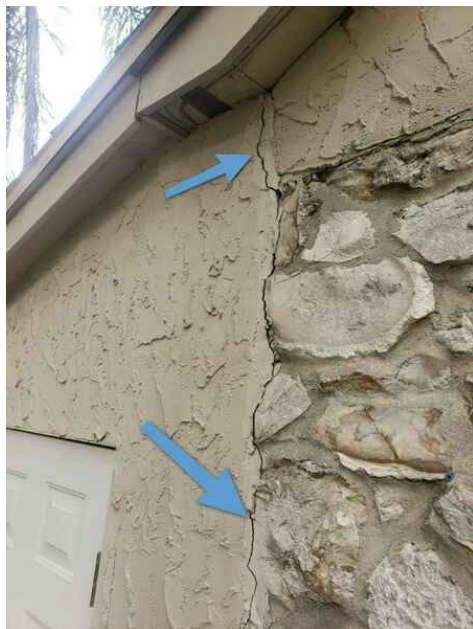
This is crack does not appear to be a structural defect however, it should be monitored as with the others, driving rain could cause water damage behind the exterior wall covering.

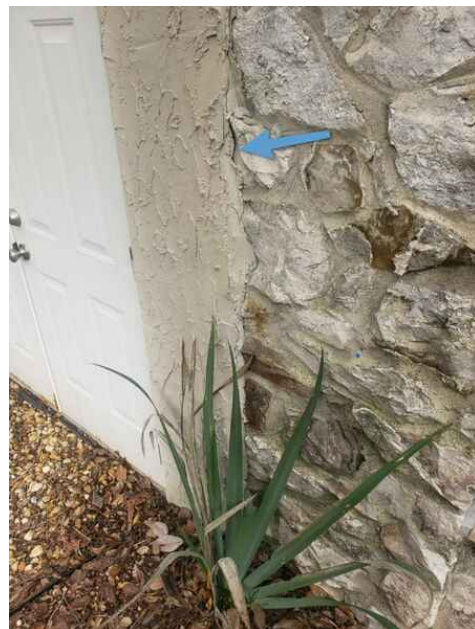
Stucco and stone lacks positive seal.

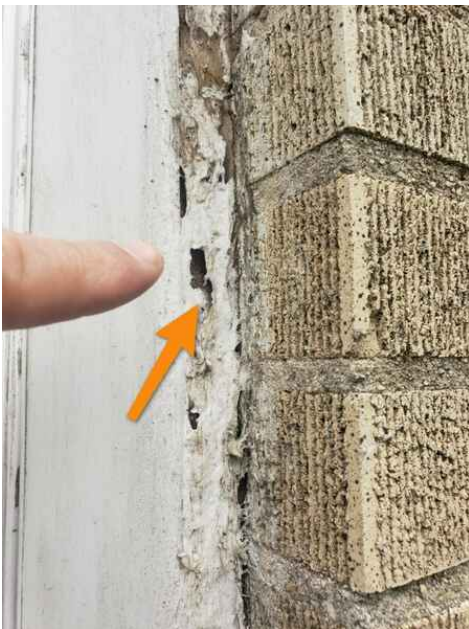
Window trim had gaps that should be filled with an appropriate sealant by a qualified contractor to help prevent moisture and insect entry.

Caulking defective

Contact a qualified professional.

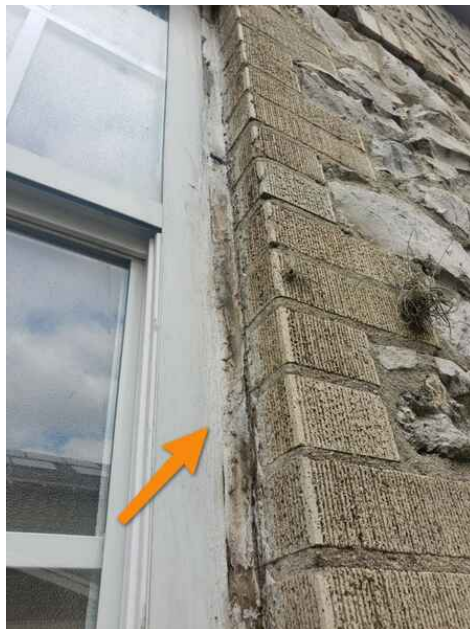
Same window, caulking defective

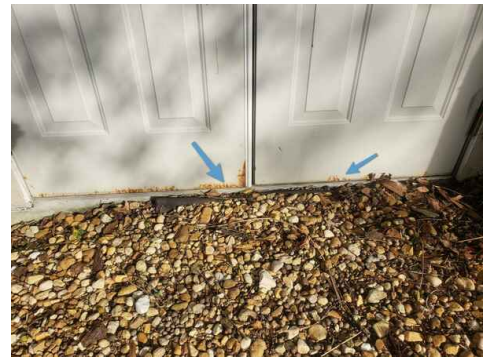
Rust found on exterior doors indicated moisture beginning to damage the door. Recommend sanding to remove rust and painting the door to extend its useful life.

Rust

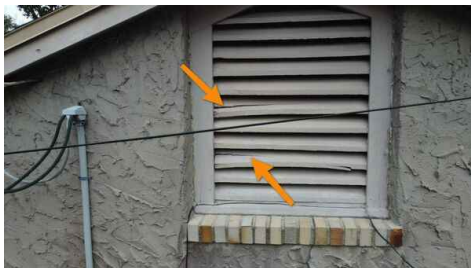
Attic vents are often located high above the ground and are difficult to inspect and therefore can fall into disrepair without detection. Wood rot in these areas should be repaired to reduce the chance of insects and animals entering the home.

(North Gable) Louver damage visible on two boards

Contact a qualified professional.

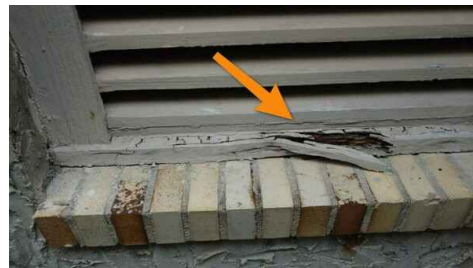
Wood rot (South Gable)

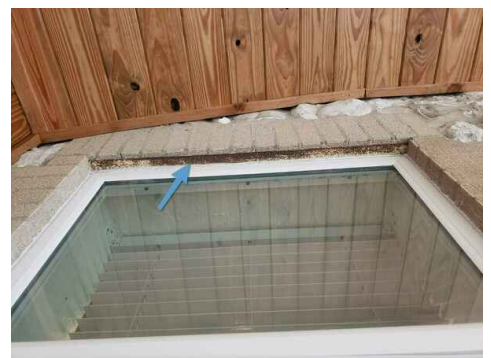
Lintel rust is cosmetic and not a structural defect. Left uncorrected it can result in discoloring the material below it with rust stains that are difficult to remove.

Lintel Rust (front porch)

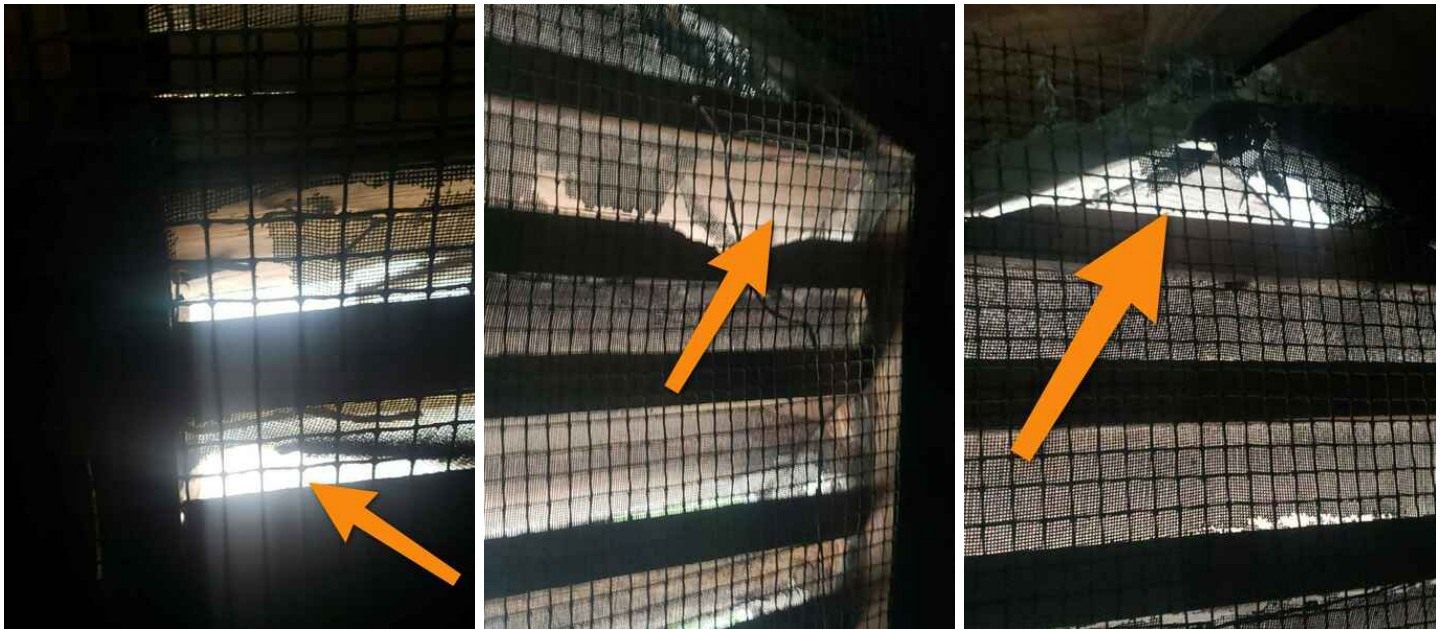
Gable vents had screen damage that will allow entry of insects, birds, squirrels, and other pests. Damaged screens or vents should be replaced by a qualified contractor.

The photos below are all of the south gable. The north gable could not be reached. Due to the age of the building, it is likely that the north end is in a similar condition. The heavy screen will keep most animals out however insects have access to the attic. No evidence of insect penetration was evident at the time of inspection.

Contact a qualified professional.

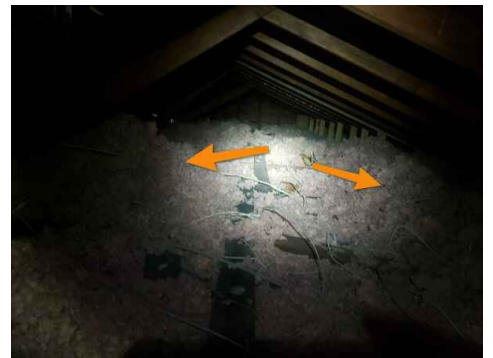
Some soffit vents were blocked by thermal insulation. This condition will reduce the amount of air flowing through the roof structure to exhaust heat and moisture to the exterior. The thermal insulation should be pulled back from any blocked vents to allow proper airflow and improve roof structure ventilation. Work should be performed by a qualified contractor.

Contact a qualified insulation contractor.

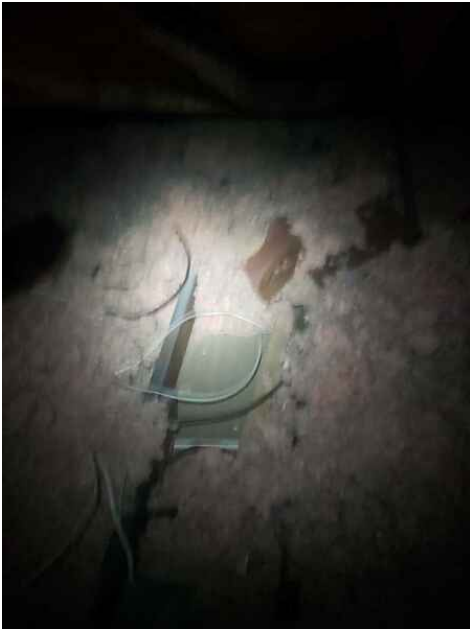
Thermal insulation in the attic was poorly-installed and had significant gaps that will result in unwanted heat gain or loss. This condition will increase heating and cooling costs and reduce comfort levels and may contribute to ice damming of the roof during the winter. Insulation should be properly distributed to cover all portions of the attic located above the home living space.

Missing insulation 1

Contact a qualified insulation contractor.

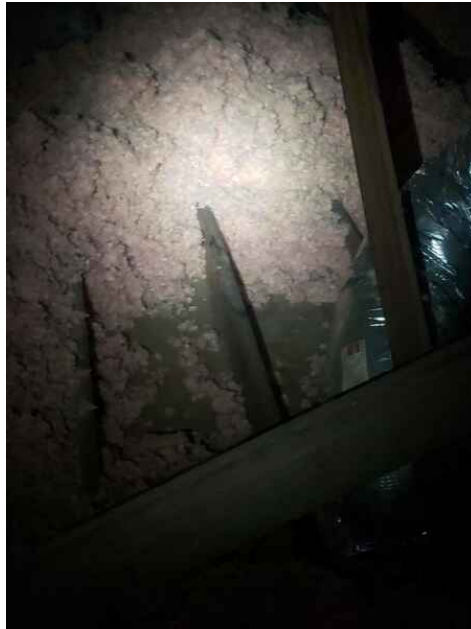
Missing insulation 2

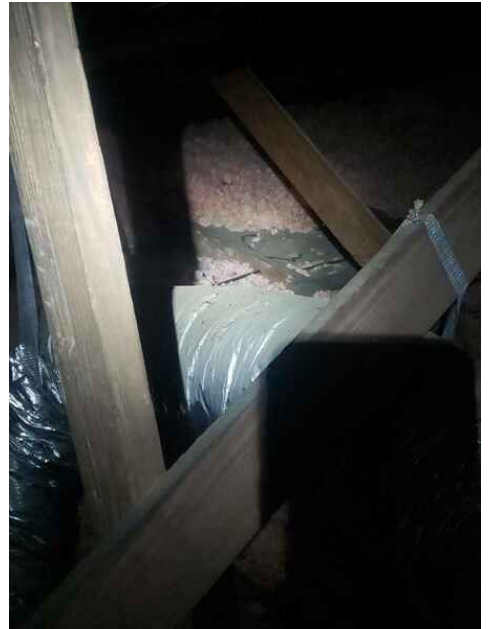
Missing insulation 3

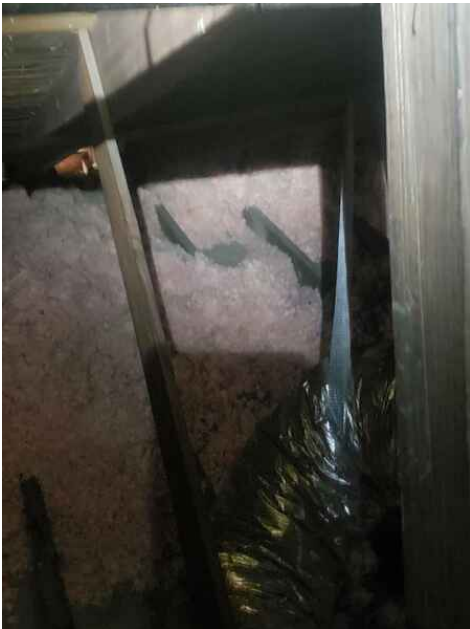
Missing insulation 4

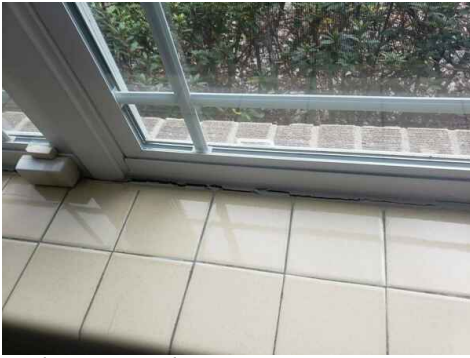
Bedroom window 1

Cracks formed around windows mounted into plaster walls may form crack in the plaster caused from expansion and contraction of different material. The window and frame expands and contracts at a different rate than the plaster around it. These cracks are normally cosmetic but should be sealed to avoid heat and air loss in addition to insect infestation.

These photos are representative of the main floor bedroom windows. There is no sign of water penetration and damage appears to be cosmetic in nature.

Contact a qualified professional.

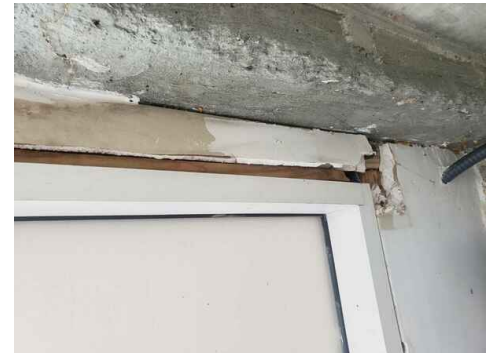
Unfinished drywall

Contact a qualified professional.

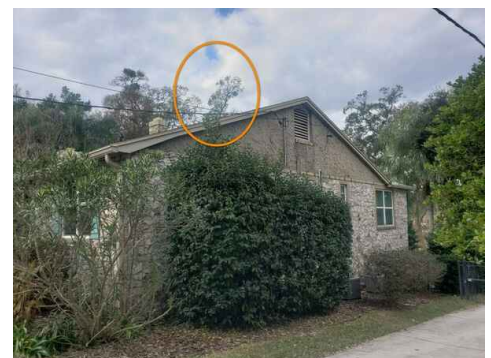
Tree growing too close to home and power line

Contact a qualified professional.

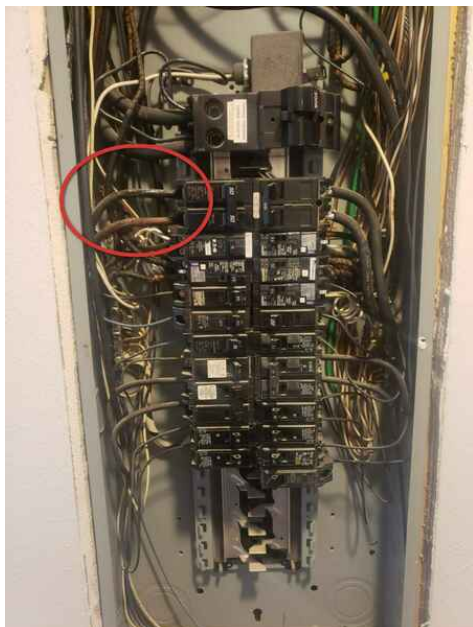
Cloth coated 50 amp wire to kitchen range

Contact a qualified electrical contractor.

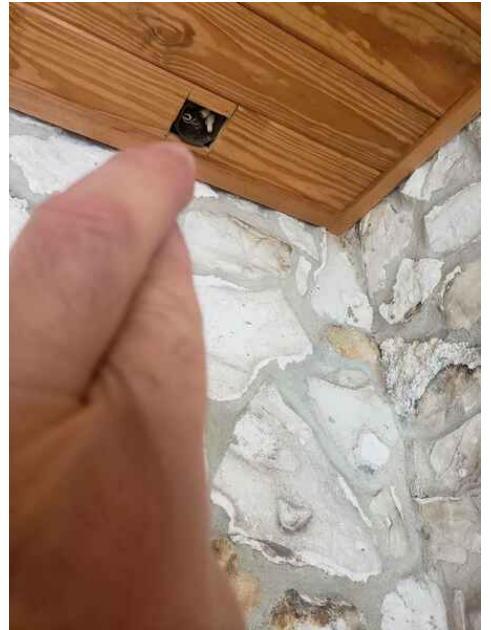
Electrical junction boxes should have cover plates.
The front porch ceiling junction box is missing a cover plate.

Recommendation
Contact a qualified electrical contractor.

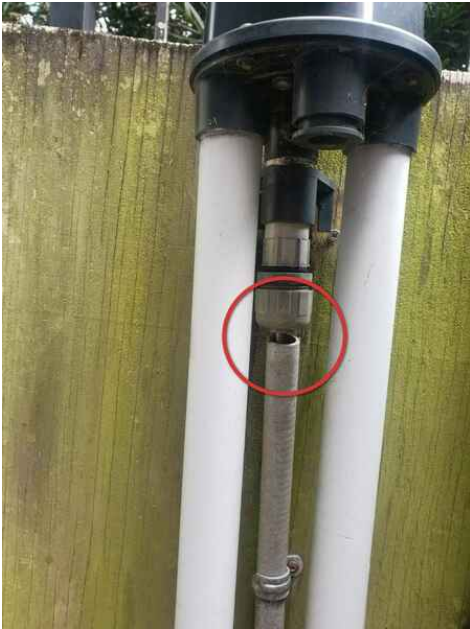
The conduit in this picture has separated from the connection to the box exposing the wires and allowing moisture to enter the conduit.
The conduit should be resecured to the connector.

Waterproof conduit separation on outdoor connection in pool mechanical area

Recommendation
Contact a qualified professional.

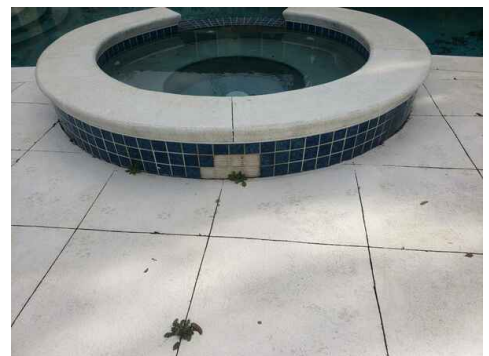
Missing tiles

Contact a qualified Swimming Pool Contractor

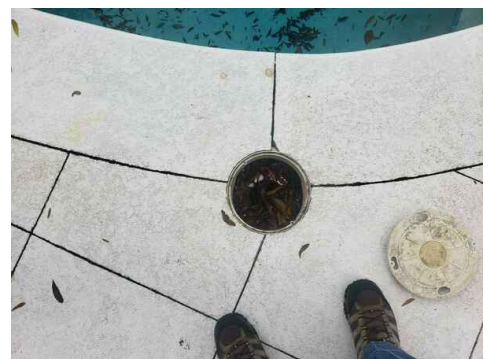
Filter basket full of leaves

Recommended DIY Project

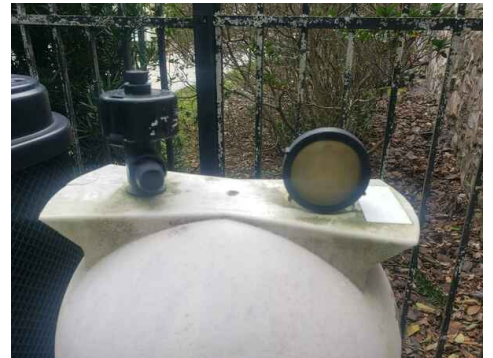
PRESSURE AUGGE: NOT OPERATIONAL

Glass cloudy and needle appears to be missing

Contact a qualified professional.
