RESIDENTIAL INSPECTION - SAMPLE

1234 Main Street
Jacksonville, FL 32224

Buyer Name
02/01/2023 9:00AM

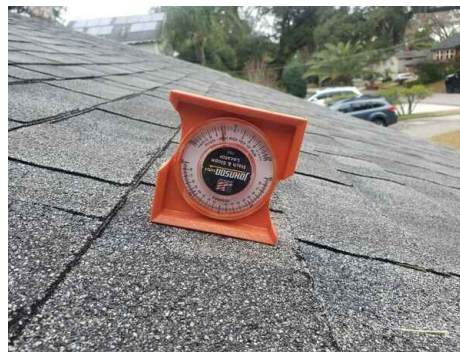
4:12 Pitch

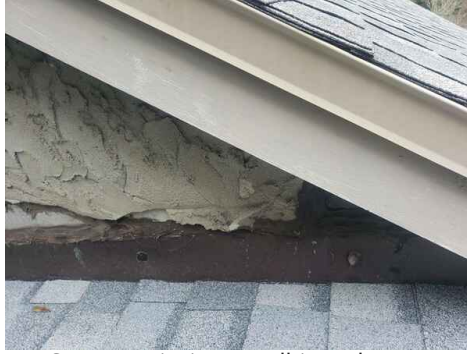
Stucco missing, caulking ok now

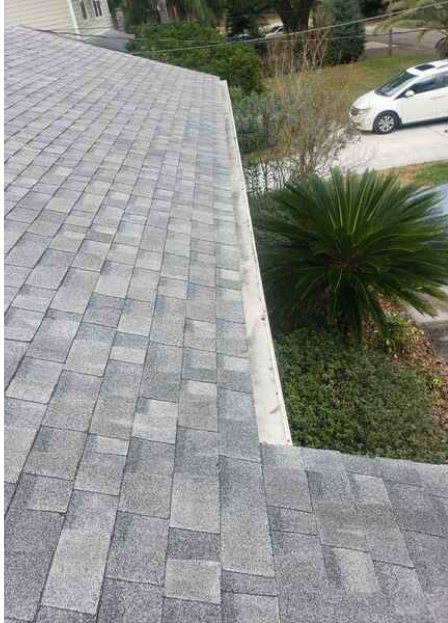
1. The roof drainage system consisted of conventional gutters hung from the roof edges feeding downspouts. The gutters had screens and no debris was detected on the screens or in the one gutter with no screen.
2. The downspout pictured below has been disconnected from the gutter, recommend reconnecting.
3. There was a hole cut in the downspout in front at the edge of the driveway, recommend covering it to keep insects and animals out.

1. Gutter leaf guards

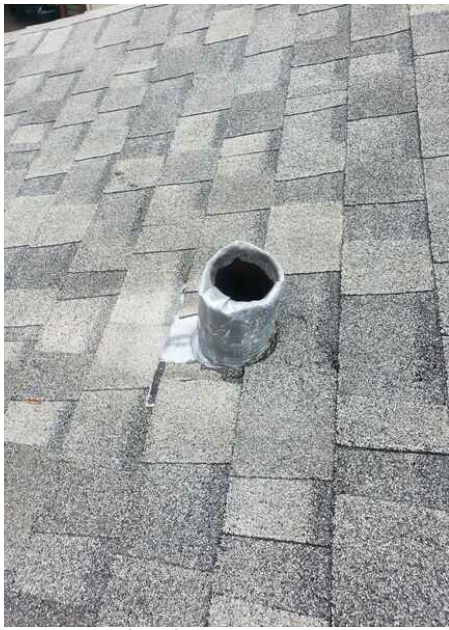
Plumbing vents were installed correctly and showed no sign of deterioration.

Plumbing Vent: 4"

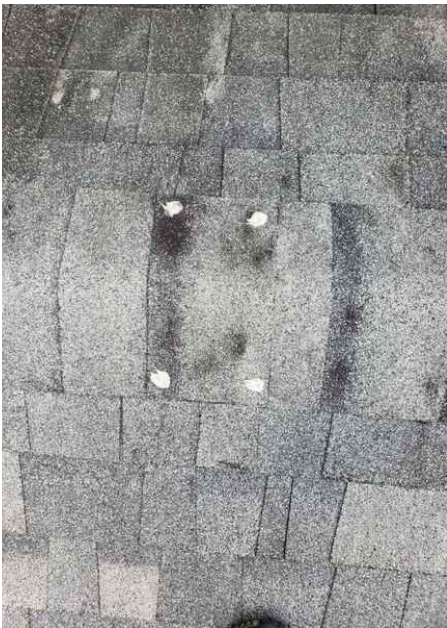
Nails sealed well

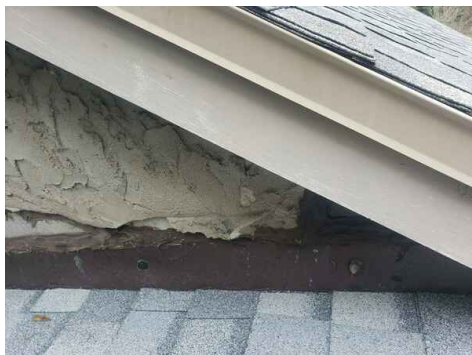
Flashing: Rubber Caulking 2

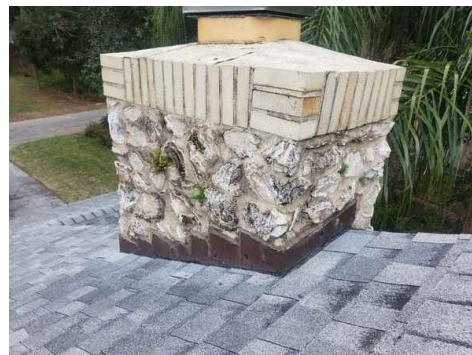
Flashing: Rubber Caulking 3

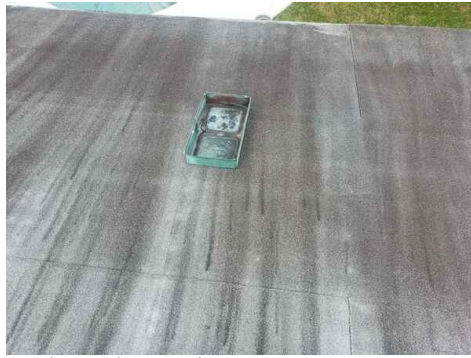
Debris on roofing material tends to hold moisture underneath. This moisture also shortens the useful life of the roofing material below it.

Back yard: Metal Pan

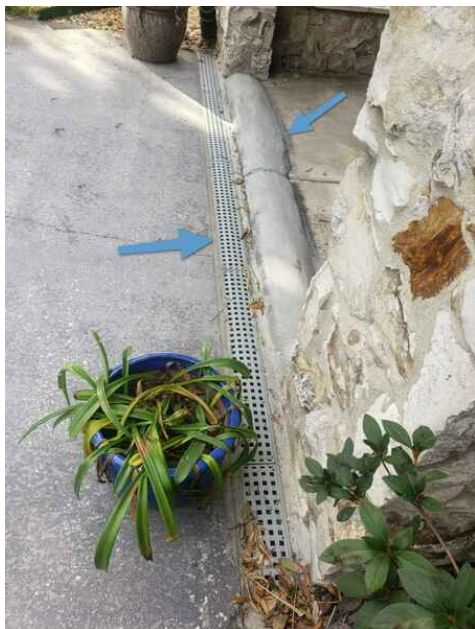
Drain and curb designed to keep water away from home.

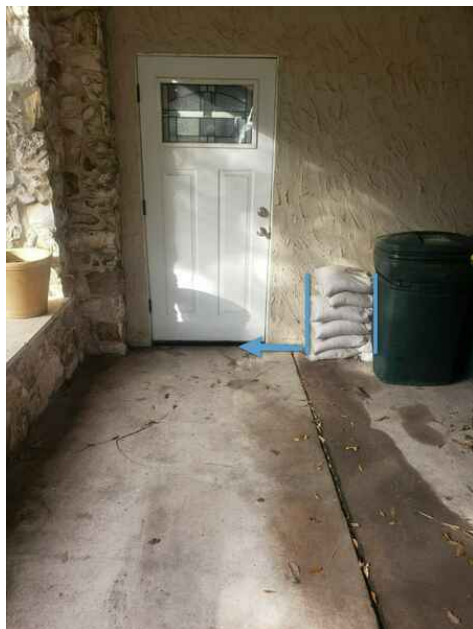
Sandbags available to block water during heavy rainfall

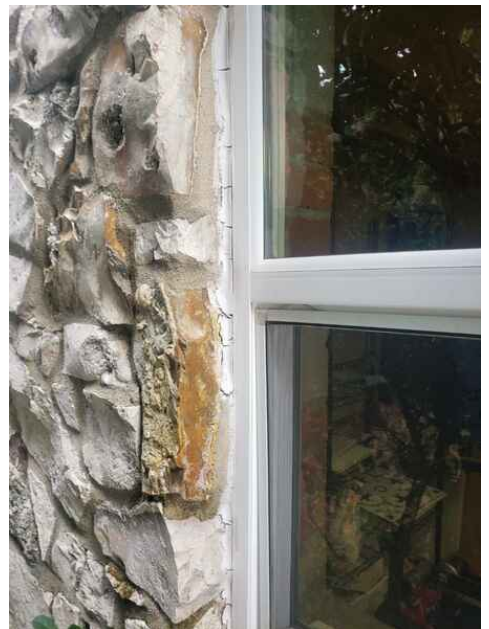
Window in back yard on north end by sewer cleanout

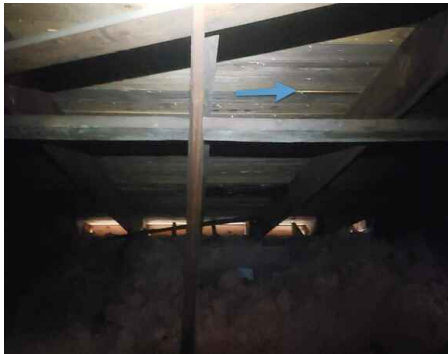
The sheathing was in good condition and showed no signs of water damage. This includes areas around roof penetrations to include chimneys.

Sheathing 1

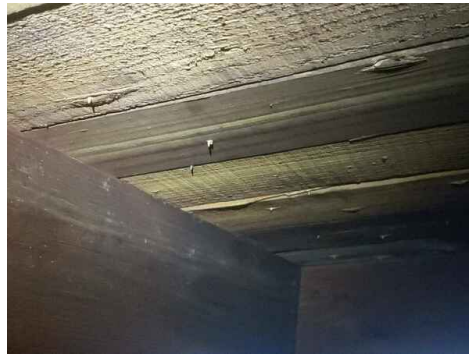
Sheathing 2

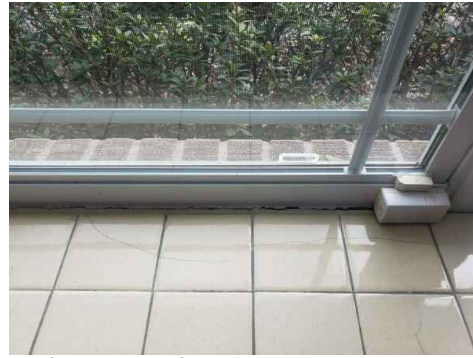
Bedroom window 2

Cracks formed around windows mounted into plaster walls may form crack in the plaster caused from expansion and contraction of different material. The window and frame expands and contracts at a different rate than the plaster around it. These cracks are normally cosmetic but should be sealed to avoid heat and air loss in addition to insect infestation.

These photos are representative of the main floor bedroom windows. There is no sign of water penetration and damage appears to be cosmetic in nature.

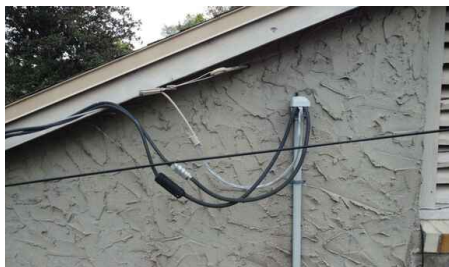
Service Drop

The overhead service-drop conductors attached directly to the home exterior. Although this is an outdated practice, the Inspector observed no deficiencies in the condition of the attachment at the time of the inspection.

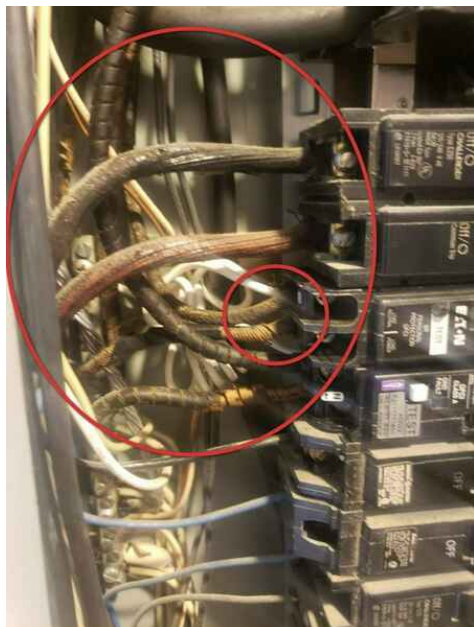
Cloth wire represents old wire that may be past its useful life. Often, wire covering decays and can cause a fire hazard in the box, in walls, and at the receptacle. Cloth wire in an electrical panel should be verified safe by a licensed contractor.

Cloth wire and double tapped wire in breaker

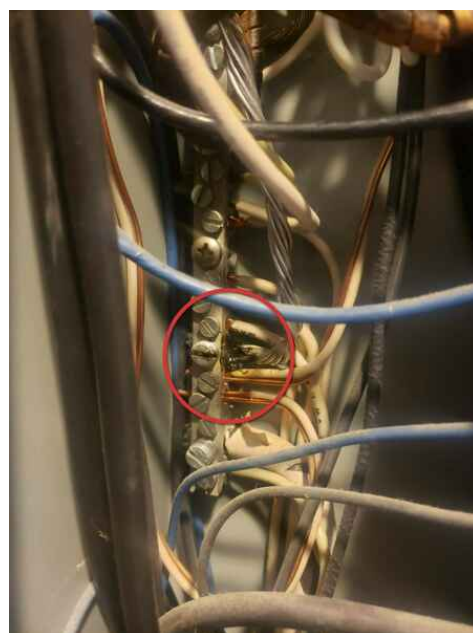
Black burned areas indicate possible arching in the electrical panel. Any indication of possible arching should be checked by a licensed electrical contractor.

The photo below indicates a possible burned spot on the grounding bar within a double tapped ground lug.

Contact a qualified electrical contractor.

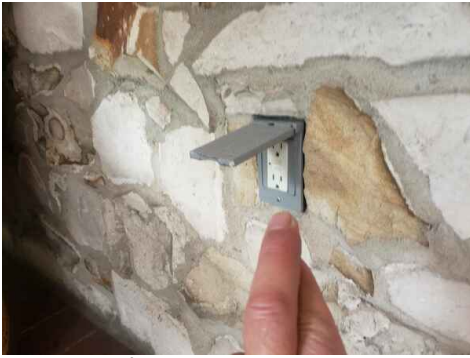
Front porch

Multiple ground fault circuit interrupter (GFCI) electrical receptacles did not respond adequately to testing. GFCI receptacles should be checked and replaced as needed by a qualified electrical contractor.

Contact a qualified electrical contractor.

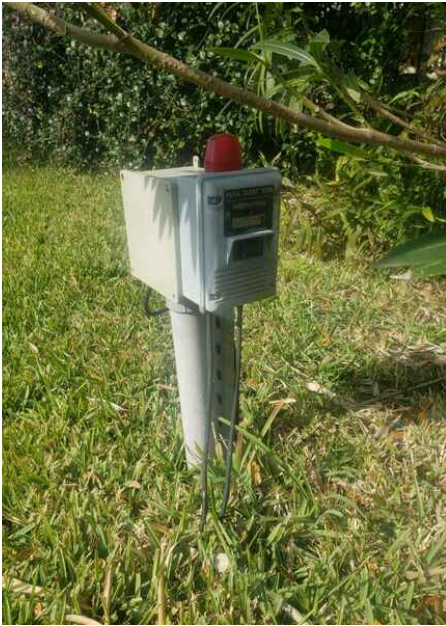
Septic Tank Warning

This septic tank warning was found in the back yard on the north side of the property line. The septic tank was not found however the inspector believes it is likely located close to the warning device.

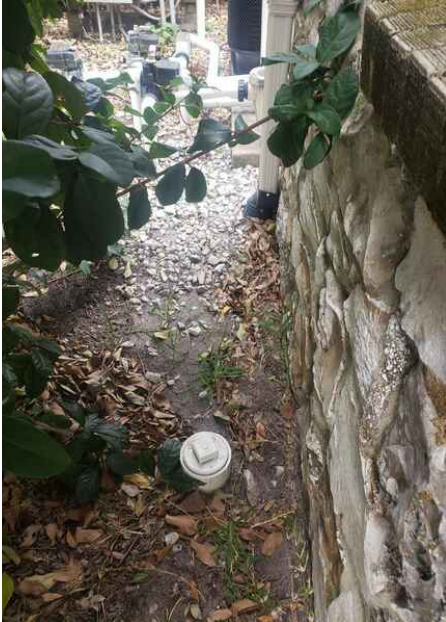
Sewer cleanout

The sewer cleanout is located in the back yard at the north corner of the home.

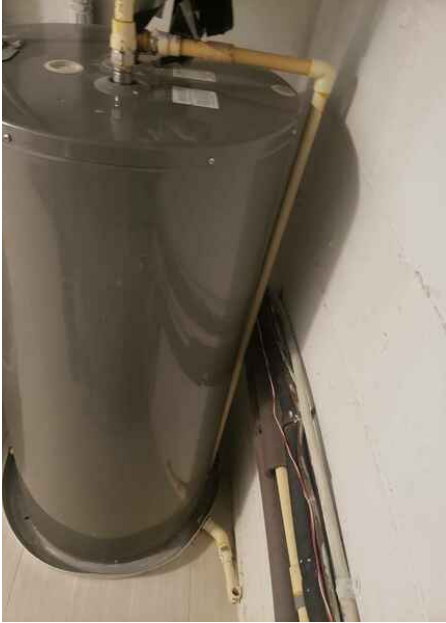
This water heater rested in a drip pan that had a properly-routed overflow pipe.

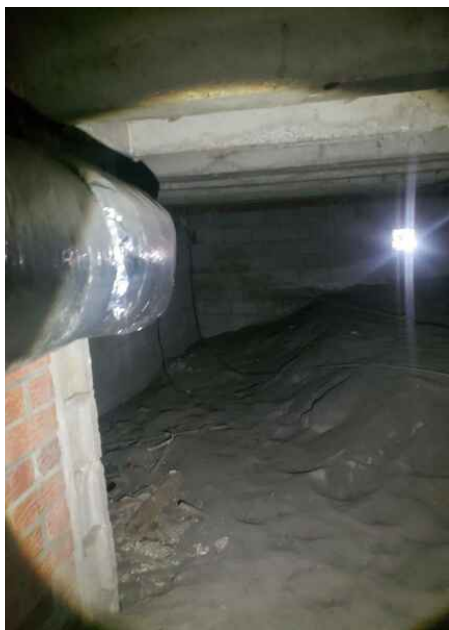
Foundation wall 1

The pictures below show evidence of possible moisture penetration on the CBU walls. When tested, the block show no abnormal levels of moisture and the reading was the same for the light and dark block. In addition, the dirt around the foundation walls was powder dry. Access to this crawlspace in through a passage door in the lower level. I recommend that this area be monitored over time and after each heavy rain or hurricane that passes through Jacksonville.

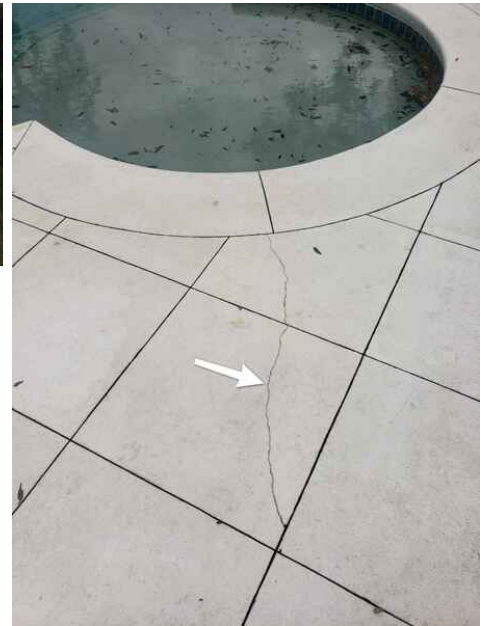
Cosmetic expansion and contraction cracks are found in the pool deck. These are hairline thing and NOT considered a defect.

expansion and contraction crack

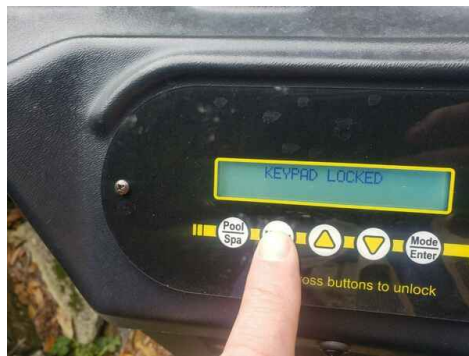
At the time of the inspection, the Inspector observed no deficiencies in the condition of the pool heating system. The system was not activated or tested. No operator manuals were provided and the keypad was locked. The heater was in new condition.

Power on, keypad locked

I did walk through the pool mechanical area with the client. I suggested he get a pool professional to test each system, provide guidance on servicing each component.

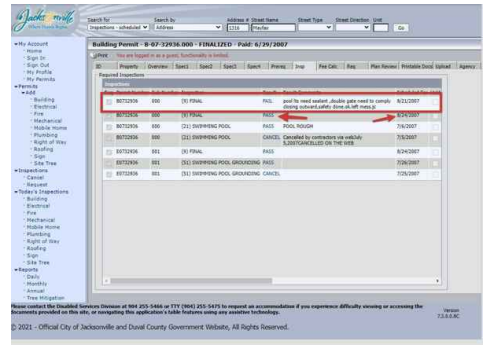
The pool did not have a fence that meets the building permit issued at the time of the pool construction. This is a safety issue and should be corrected by a professional fence company.

Building Permit Information for Pool in 2007: On 6/29/2007

"571-228-9373 POOL NOT APPROVED FOR DIVING BOARD INSTALLATION.PROVIDE AT LEAST 4FT HIGH FENCE AROUND POOL W/SELF CLOSING,SELF LATCHING, LOCKABLE GATES.PROVIDE LOCKING DEVICES ON DOORS OF A DWELLING W/DIRECT ACCESS TO A FENCED SWIMMING POOL.INGROUND CONCRETE POOL & SPA AVG 14X303.5-7 DEPTH."
